Manhole Inspection Summary

Manhole # S15EE2030MH

Location Address: **1819 FAIRBANK RD**

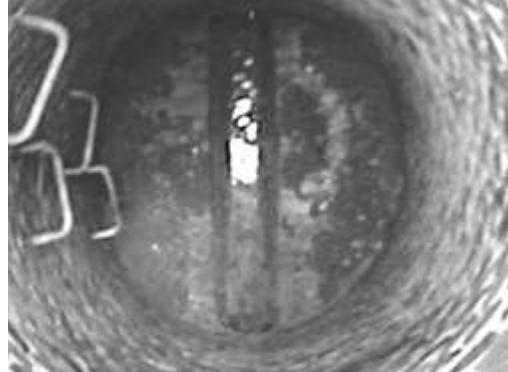
Top View

Adjustment infiltration. Evidence of surcharge - Bench debris. Channel debris.

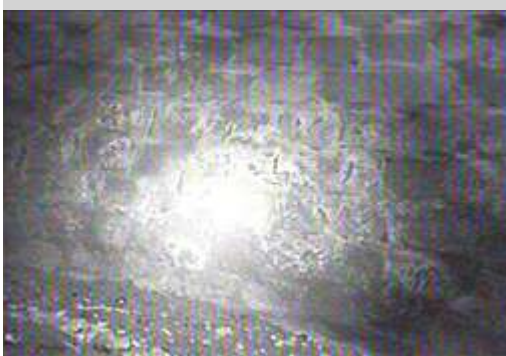
Defect

Barrel deterioration and infiltration.

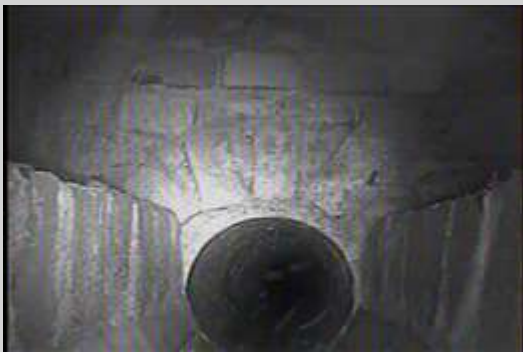
8 in. Circular Gravity Sewer Pipe Out @ 12 O'Clock

Infiltration: **None** Pipe Seal Cond: **Unknown**

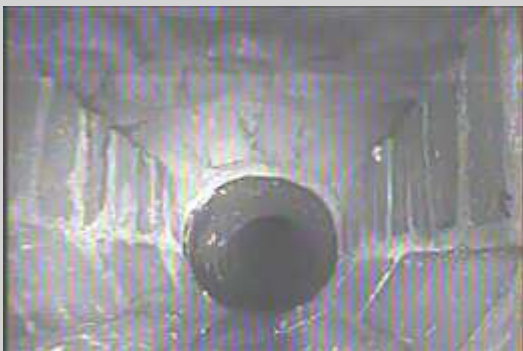
8 in. Circular Gravity Sewer Pipe In @ 6 O'Clock

Infiltration: **Evidence** Pipe Seal Cond: **Cracked**
